XIM Peel Bond Comments from Professional Painting Contractors

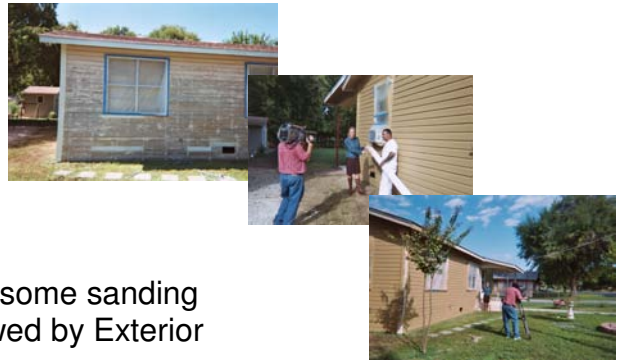
Type of Surface: Old wood siding that was peeling and had not been coated in years.

Problem: Can we make these homes look good again without the expense of residing?

Solution: Removal of old peeling paint followed by some sanding and then a thick application of XIM Peel Bond followed by Exterior Latex Paint.

Note: The initial job was filmed by KENS, Channel 5 TV in San Antonio. The property owner and the TV crew were amazed at the resulting appearance of the home.

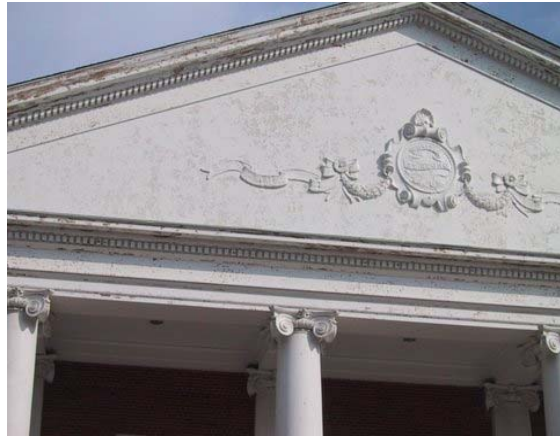
Problem- cracked, peeling paint on buildings. Short durability of existing coatings

Cal uses XIM products on a variety of jobs at the college. He really likes using Peel Bond with SW Durations for a long lasting finish on exterior wood surfaces. He is impressed with the look that Peel Bond provides along with its high build qualities and durability.
